**EVALUATION OF AIRCRAFT WINDSHIELD MATERIALS
IN A SIMULATED SUPERSONIC FLIGHT ENVIRONMENT**

J.B. HOFFMAN
Douglas Aircraft Company
McDonnell Douglas Corporation
3855 Lakewood Boulevard
Long Beach, California 90846

JUNE 1979

TECHNICAL REPORT AFFDL-TR-79-3058

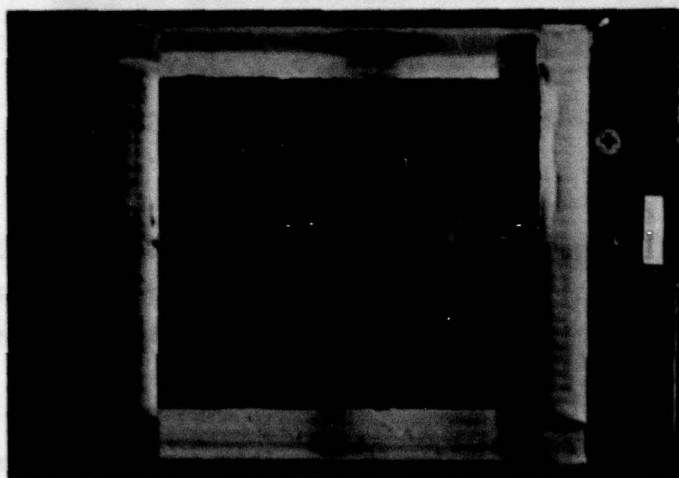
Figure 33. Post-Test Photo of Specimen SK21.

Specimen SK21, Figure 33, was tested at three Mach numbers. The groove sealant became discolored during the Mach 2.4 injection and the discoloring continued during subsequent injections. The reddish discoloration was removed easily from the sealant by lightly scraping and appears to be residue from the fiberglass spacer at the forward edge. The groove sealant separated from the face ply along the aft side during the final injection. The sealant remained pliable. Air flow was from left to right in the figure.

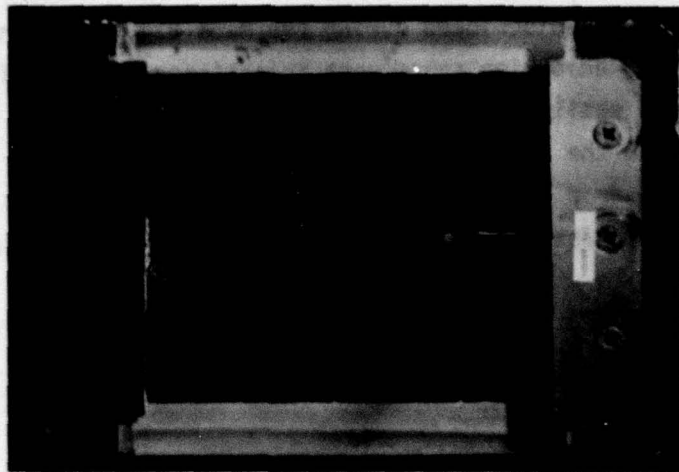
Figure 34. Post-Test Photo of Specimen SK22.

Specimen SK22, Figure 34, was tested at Mach 2.6 and Mach 3.0. This specimen was damaged by erosion of the adhesive under the aft steel retainer. The aft edge of the polycarbonate experienced severe bubbling and deformation.

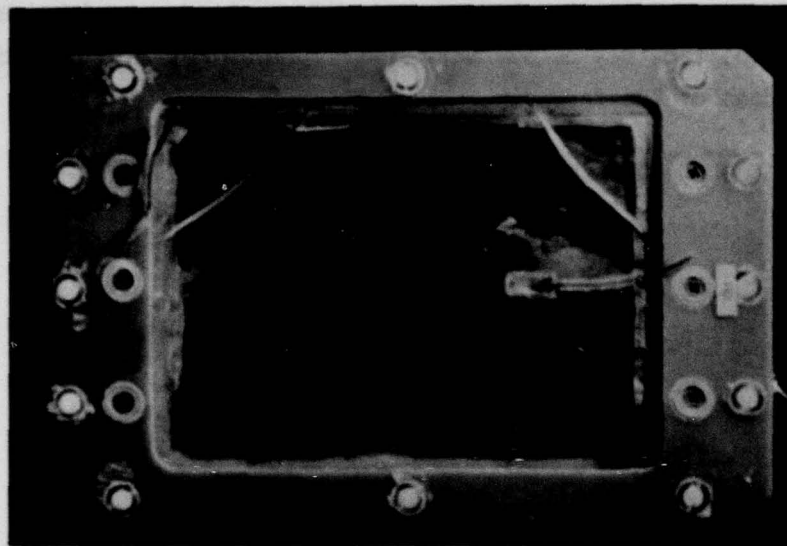
Figure 37. Post-Test Photo of Specimen GY21.

The acrylic face ply of GY21, shown in Figure 37, had been cracked in two places during fabrication. These cracks expanded during the Mach 2.4 tunnel injection and precipitated face ply delamination.

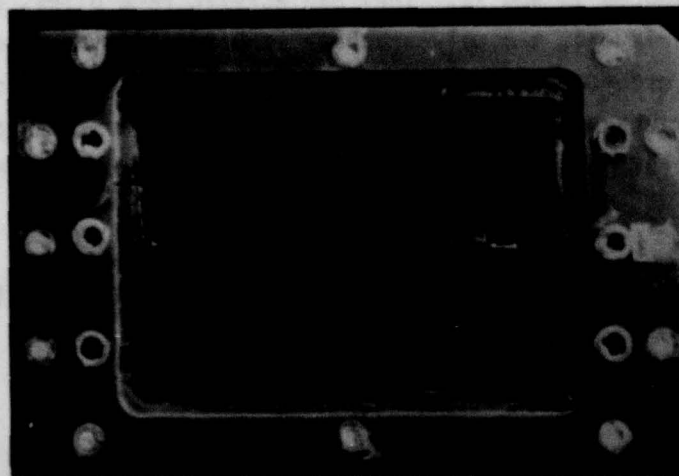
Figure 38. Post-Test Photo of Specimen GY22.

The rabbeted area of GY22, Figure 38, ruptured along the aft edge during the Mach 2.6 exposure and exposed the interlayer. Face ply delamination spread across most of the surface. The fiberglass filled polycarbonate bushings (part of the edge attachment system) melted and flowed around the screws.

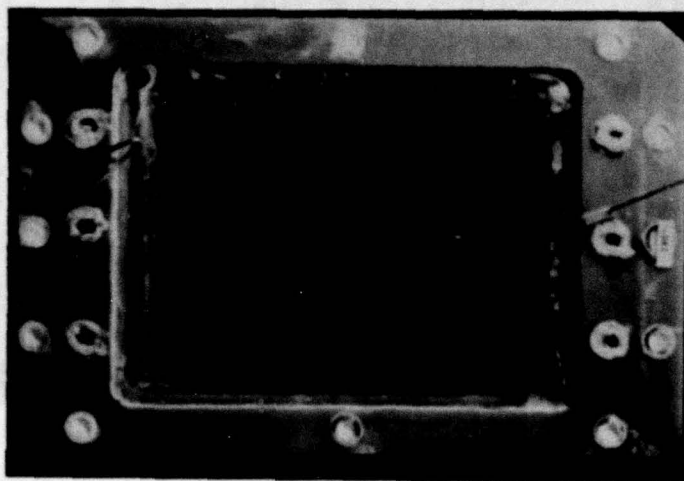
Figure 39. Post-Test Photo of Specimen GY23.

GY23, Figure 39, reacted similarly to GY22. Holes were burned in the rabbeted area of the face ply and the bushings melted during a Mach 3.0 exposure. This specimen also had a cracked face ply due to fabrication procedures. The face ply became very rough. Delamination occurred only around the edges of the face ply.

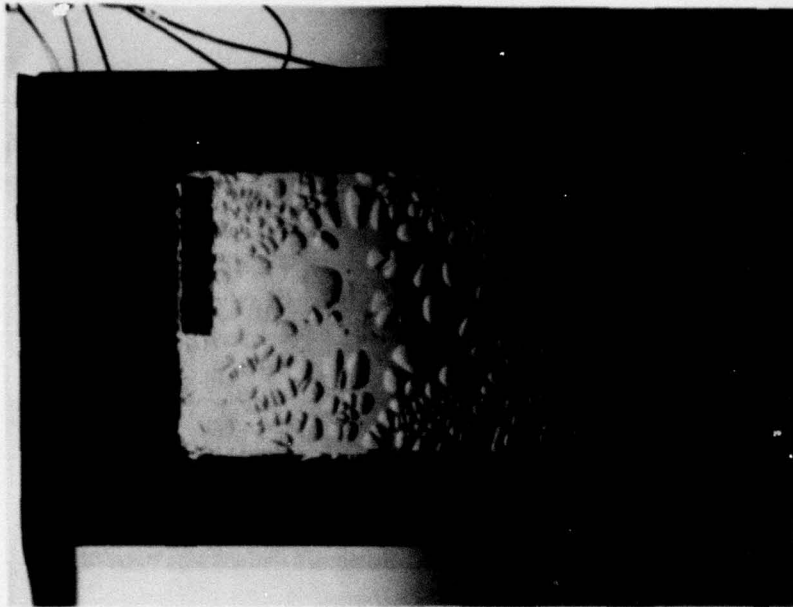
Figure 45. Post-Test Photo of Specimen PPG22A.

Specimen PPG22A (identical to PPG22) sustained severe interlayer bubbling during its initial tunnel injection at Mach 2.6 and was retracted early. The flat shaped bubbles are apparently at the face ply/interlayer interface, and are shown in Figure 45.

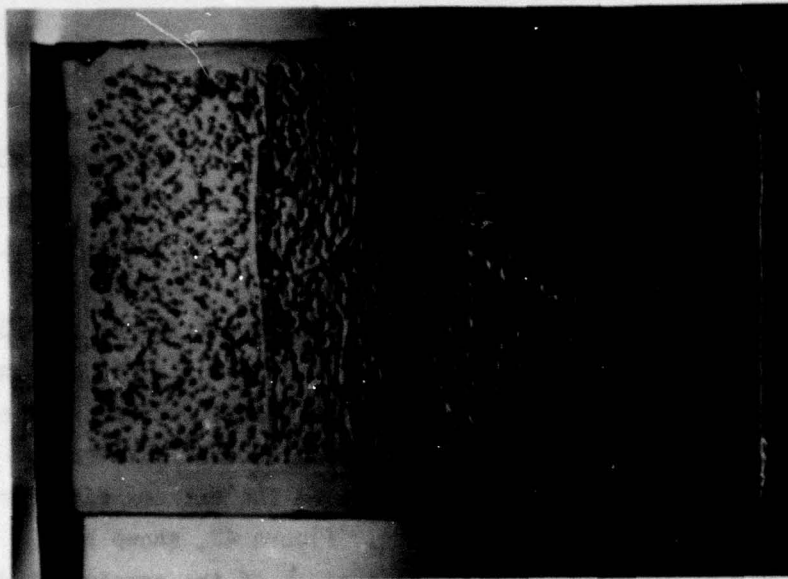
Figure 47. Post-Test Photo of Specimen TEX21.

SPECIMEN	EXPOSURE TIME (MIN.) MACH NO.			DESCRIPTION OF SPECIMEN DAMAGE	EDGE DEFORMATION
	2.4	2.6	3.0		
TEX21	5			Hazing occurred at 1 minute on right hand side (looking forward). No change after 1.5 minutes.	Slight
	10			No Change.	
			1	Severe bubbling of outer surface occurred immediately.	
TEX21A		5		Slight bubbling occurred on outer surface. Aft corner deformed and bubbles in polycarbonate. Approximately 5 cracks appeared in outer surface, 3 to 4 inches long, resembling "dry mud" cracks. Very fine ripples occurred on surface along forward and aft edge where frame ended.	Yes
